# BELZONA STEMS LEAK AND REPAIRS GROUND WATER CLARIFIER NOZZLE

ID: 10049

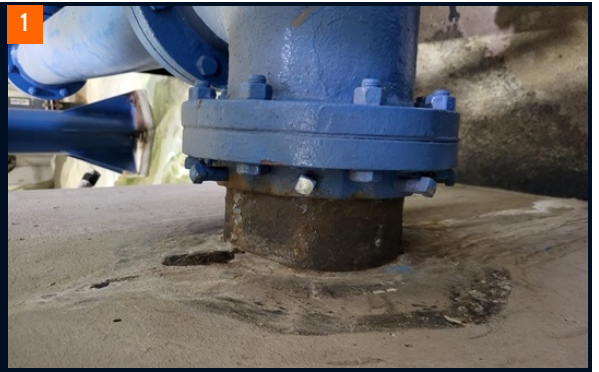
Ground water clarifier nozzle and parts on the tank close to it were leaking and required stemming the leak and repairing the eroded parts.

1. Before surface preparation.
2. After surface preparation
3. After application of Belzona 1161
4. After application of Belzona 5831
