# PASSENGER FERRY ENGINE CYLINDER REPAIR

ID: 10053

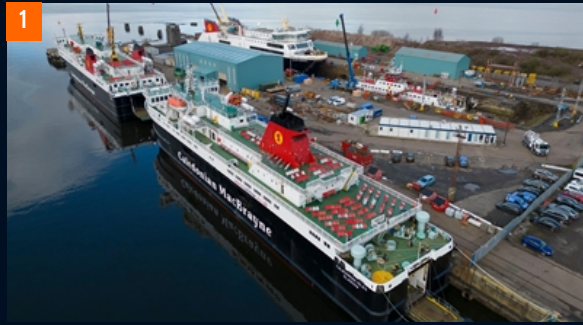
An engine used to run one of the bow thrusters was found to have damage within its engine cylinders. This was suspected to be caused by cavitation between the wall & the cylinder liners.

1. Vessel docked during overhaul
2. Damaged area identified
3. Surface preparation
4. Belzona 1311 applied & then machined flat with the surrounding metal

The identified areas were ground out using an angle grinder. Belzona 1311 was then applied 'proud' of the lost metal. Once the product had reached its initial cure stage it was then machined down flat with the metal.
