# SEALING PIPES AROUND A CHEMICAL SUMP

ID: 10054

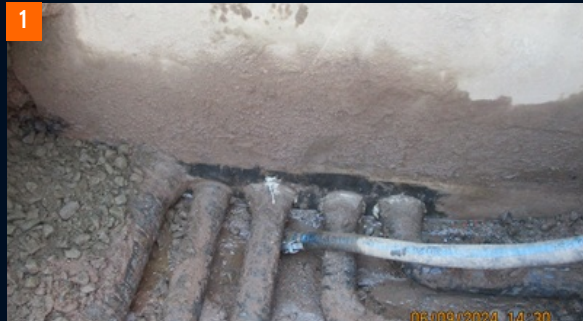
A series of pipes entering a chemical sump were found to be a leak path for water to enter the sump. This leak path needed to be stopped as the chemicals within the sump could react violently with water

1. Pipe excavation
2. Close up showing leak path
3. Surface preparation
4. Belzona 4911 & Belzona 4111 applied
