# PLASTIC TANK PIPE REPAIRS

ID: 10055

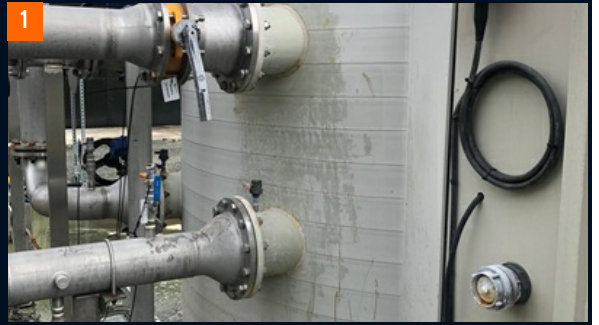
A plastic tank had developed several cracks around pipes. A replacement was planned but to get production through to that point a temporary fix was requested.

1. Leaking area
2. Surface preparation on the plastic tank
3. Belzona 1221 applied
4. Belzona SuperWrap II system applied
