# BELZONA GIVES OLD PUMP NEW LEASE OF LIFE

ID: 1006

Sea Water Pump

Coal-fired power plant, Croatia

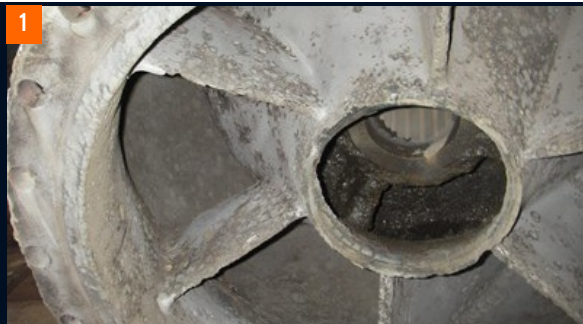
Deterioration due to bimetallic corrosion and sea water erosion.

1. Damaged seawater pump
2. Applying Belzona 1311
3. Belzona 1311 application complete
4. Belzona 1321 applied
