# BELZONA IN THE PRESS

ID: 1007

A screw fell into the printing machine causing damage to the roller.

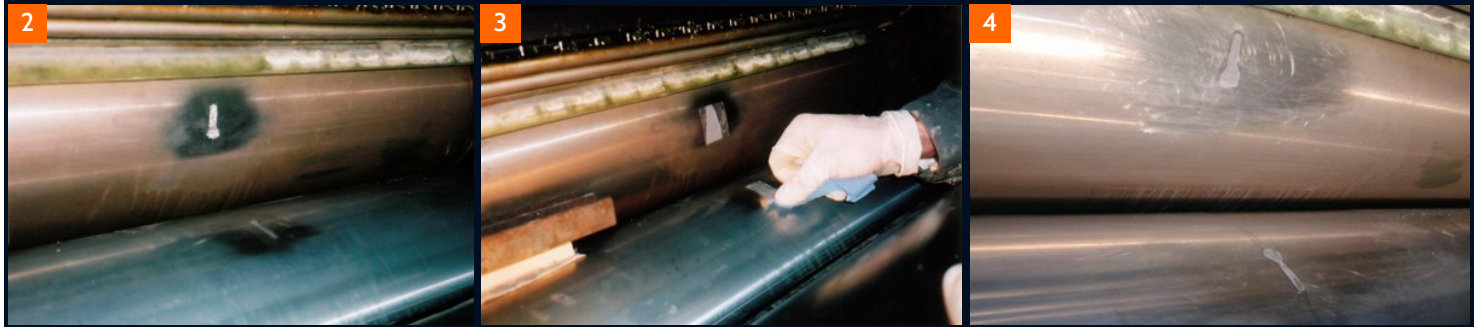
## PHOTOS

Printing machine Damaged roller with imprint from screw clearly evident  
Ongoing application Application completed.

Application was carried out in accordance with a modified version of Belzona System Leaflet MPT-2.

Belzona 1221 (Super E Metal)
