# BELZONA SUPERWRAP II APPLIED ON A 58" FLARE LINE AT A PETROCHEMICAL PLANT IN SAUDI ARABIA

ID: 10072

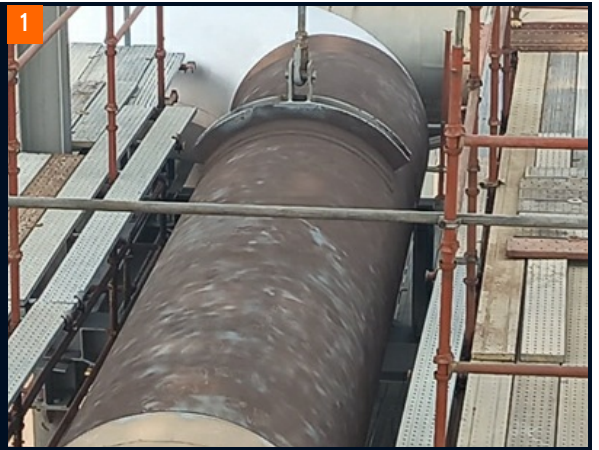
The 58" flare line had experienced significant wall-thickness loss, posing a serious risk to its structural integrity.

1. A 58" flare line in a petrochemical plant had suffered significant wall-thickness loss, compromising its structural integrity.
2. General overview of the flare line structure.
3. Application of the Belzona SuperWrap II system in progress.
4. Completed application of Belzona SuperWrap II on the flare line.

Using Belzona 1983 (SuperWrap II) resin with Belzona 9381 carbon fiber reinforcement sheets, the repair restored the flare line's integrity and ensured a durable, long-term solution.
