# DAMAGE FROM TRAILER LANDING LEGS, REPAIRED BY BELZONA

ID: 10073

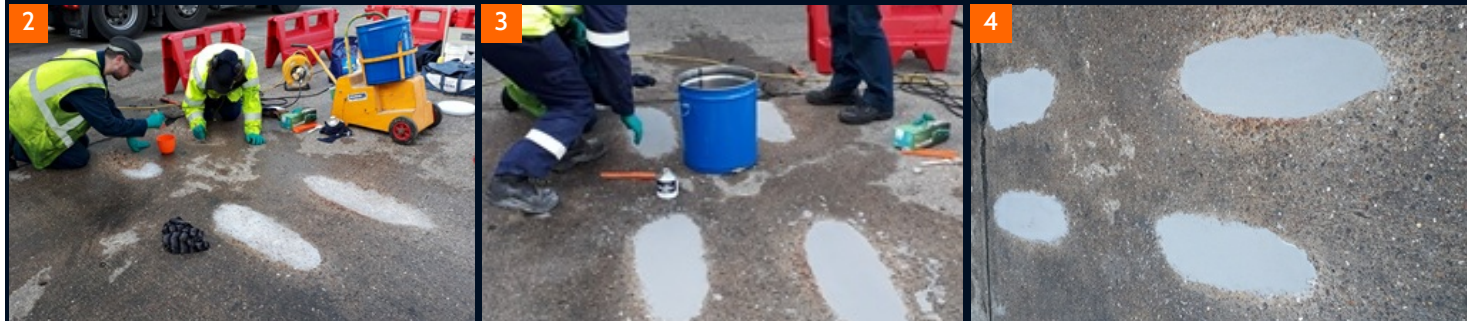
The Landing legs on the 40' trailers had worn depressions into the concrete floors. These were causing problems with fork lift traffic and other vehicles as some of the depressions were over 40mm deep

1. Showing landing legs causing wear to concrete parking area near loading doors
2. Areas cleaned and dried, the conditioned with Belzona 4911
3. In-house training given to their own team to help them carry out simple repairs in-house
4. Completed with Belzona 4131 and feather edged

Cleans and dried the concrete using absorbent kit

All loose and friable material removed

Belzona 4911 applied with short bristled brush

Belzona 4131 applied by gloved hand and compressed using finishing trowel

The works were finished in one afternoon and cured before the business re-opened on the Monday morning. The works were carried out under Belzona supervision using their own staff in order to enable them to pursue further repairs as and when they needed to do them
