# CONCRETE REPAIRS TO HEAVY MANUFACTURING FLOOR

ID: 10074

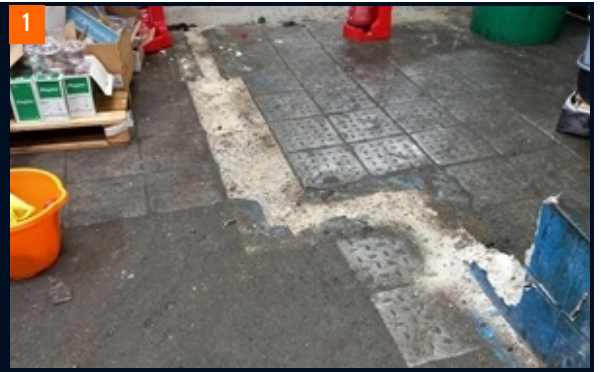
Areas of a heavy industrial floor were compromised and had started to break up, some of which had been repaired previously, though these repairs had failed

1. Showing one of the heavily damaged areas
2. Cleaning area prior to application
3. Application of Belzona 4911 TX Conditioner
4. Completed application using Belzona 4131
