# BELZONA PROTECTS A DRYER ROLLER IN A PAPER MANUFACTURING PLANT

ID: 10077

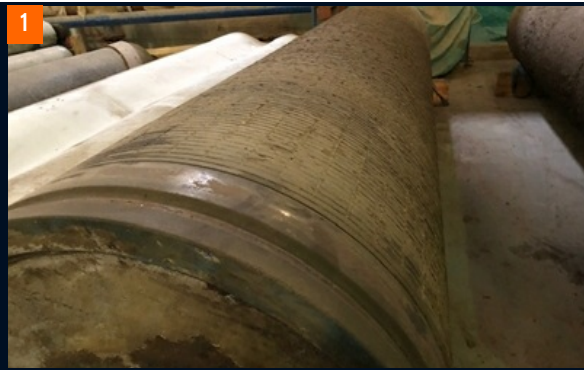
The dryer roller surface was suffering from severe corrosion due to the chemicals used in the wash solution coupled with elevated temperature and high humidity.

1. Corroded dryer roller caused by chemical washing, high temperature and humidity
2. Close-up view of corroded dryer roller surface
3. Surface preparation via abrasive grit blasting
4. Dryer roller after the application of Belzona 1511 (Super HT-Metal) and Belzona 1391T to restore metal loss
