# WAREHOUSE CAGE REPAIRS

ID: 10080

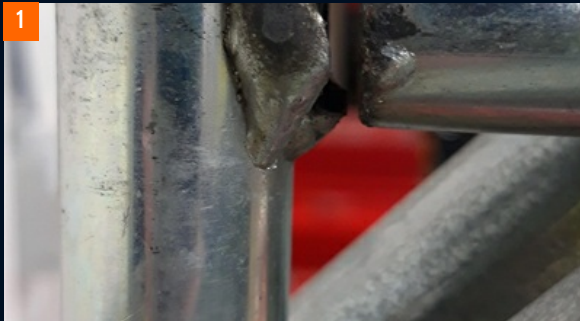
A large number of cages were failing at the welded joints and were virtually impossible to re weld to effect a conventional repair

1. Typical failed weld on a transportation cage
2. Other typical fails on welds due to general use and wear and tear
3. Belzona repair using Belzona 1111 and reinforcing sheet
4. A further close up of the repair
