# STEEL MILL SLUICE REPAIR BY BELZONA COMPOSITE REPAIR SYSTEM IN NEW ZEALAND

ID: 10081

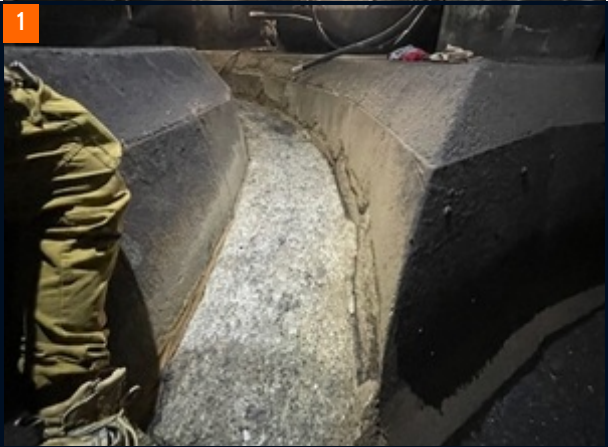
1. The condition of the concrete after the sluice had been drained and cleared of beards and grit.
2. The channel was rebuilt using Belzona 4151 (Magma Quartz Resins) and locally sourced fine quartz sand and then lined with alumina tiles using Belzona 1321 (Ceramic S-Metal) as the adhesive.
3. Once the Belzona 1321 (Ceramic S-Metal) had cured, the fabric backing was removed, and the area was frost-blasted in preparation for grouting with Belzona 1812 (Ceramic Carbide FP).
4. The Belzona system exhibits virtually no wear after 3 months of service in this particularly aggressive environment and the customer has now asked us to complete an additional 20 meters of sluice for them.

1. The channel was dammed off, drained, and cleared of all debris. Five lineal meters were then grit-blasted in preparation for the application.
2. Belzona 4151 (Magma-Quartz Resin) was mixed with quartz sand in a resin-rich mixture and applied to the channel to restore its original geometry and create a smooth surface for the alumina tile system.
