# BELZONA SAVES AUTOMOBILE PLANT SHUTDOWN BY REPAIRING DAMAGED FAN SHAFT IN SITU WITHIN 20 HOURS

ID: 10088

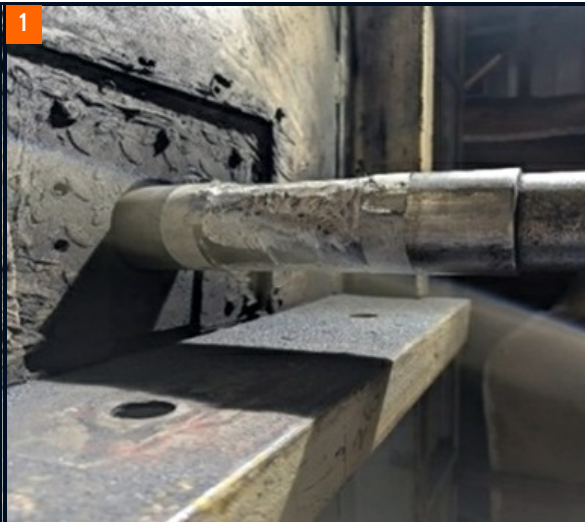
The fan shaft of the air supply machine in the paint shop has worn at the bearing journal area, causing the machine to malfunction. As a result, dust accumulation on the painted vehicles now exceeds the allowable limit.

1. The fan shaft of the air supply machine was prepared manually.
2. Applied Belzona 1111 (Super Metal) using a template with Belzona 9411 release agent.
3. The application was completed to the desired dimensions.
4. The bearing was fitted onto the repaired area.

1. Burn the damaged area of the shaft using an oxy-acetylene flame.
2. Clean the area with Belzona 9111 Cleaner/Degreaser.
3. Roughen the surface using a conical Totem cutter.
4. Clean the surface again with Belzona 9111 Cleaner/Degreaser.
5. Apply Belzona 9411 (Release Agent) on the prefabricated form/template, including all bolts, and allow it to dry.
6. Apply Belzona 1111 (Super Metal) to the prepared area of the shaft, and also apply a layer on the inner side of the form/template.
7. Fix the form/template onto the shaft, insert the bolts, and tighten to the desired dimension.
