# BELZONA COOLING TOWER BASIN REPAIR

ID: 10091

## PROBLEM

Cooling tower basin was experiencing deterioration and required a face lift.

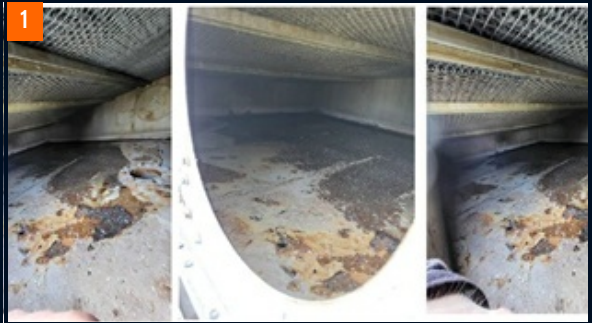
1. Basin before repair
2. Basin after repair
3. Completed application

Power tool cleaning was carried out on the surface before the pitting was covered with Belzona 1161. Two coats of Belzona 5831 was then applied afterwards.
