# MITIGATING THE ABRASIVE EFFECT OF ASH WITH BELZONA LINING

ID: 10092

## PROBLEM

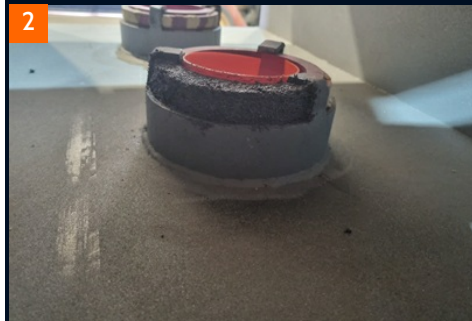
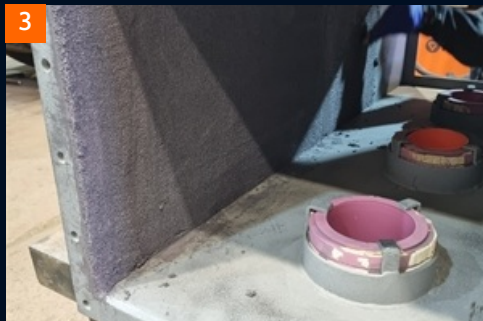
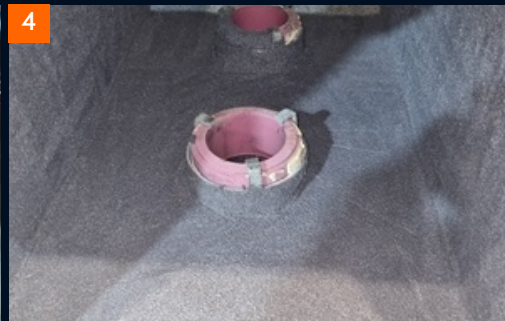
1. Grit blasted element before application.
2. Application of Belzona 1812 on side openings, using mixing bowl as a former.
3. Application of Belzona 1812 on internal surfaces.
4. Application completed.

Application was carried out in accordance with Belzona Know-How System Leaflet SHM-13. Surfaces were grit blasted and degreased with acetone. Belzona 1812 was applied to all internal surfaces of the element using Belzona application tools.
