# BELZONA PROTECTION OF A COOLING WATER SEAWATER LINE IN A SAUDI ARABIAN POWER PLANT

ID: 10093

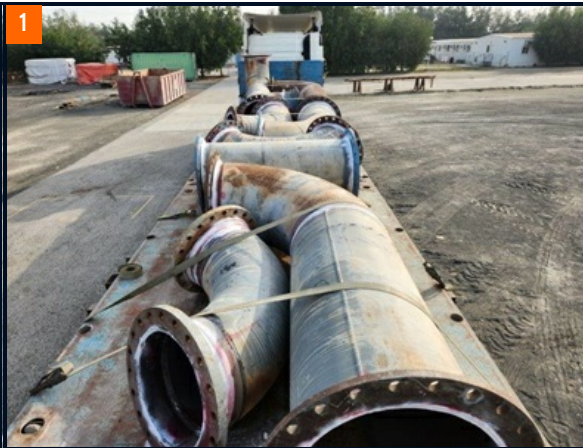
The seawater piping in the power plant exhibited significant internal degradation, characterized by corrosion, erosion, and substantial metal loss. In addition to the internal damage, the piping was also subjected to external corrosion due to persistent moisture exposure at its installation location.

1. General overview of the seawater spools.
2. The spools were abrasive grit blasted, and the welds and areas of significant metal loss were built up and faired using Belzona 1311 (Ceramic R-Metal).
3. Application of Belzona 1321 (Ceramic S-Metal), an erosion-corrosion resistant lining, applied internally.
4. Application of Belzona 5811 (Immersion Grade) system applied externally.
