# PM2 DRYER ROLLER PROTECTED WITH BELZONA

ID: 10095

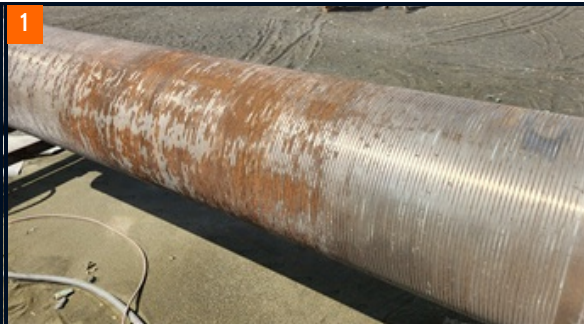
A dryer roller experienced heavy corrosion and erosion attack, requiring a repair solution to restore the roller's functional capacity and ensure consistent production performance.

1. A dryer roller suffered corrosion & erosion attack
2. Surface preparation prior to the application of Belzona 1391T
3. First coat of Belzona 1391T
4. Complete application of two coats of Belzona 1391T
