# BELZONA BRINGS SPLIT CASE PUMP BACK TO LIFE

ID: 10097

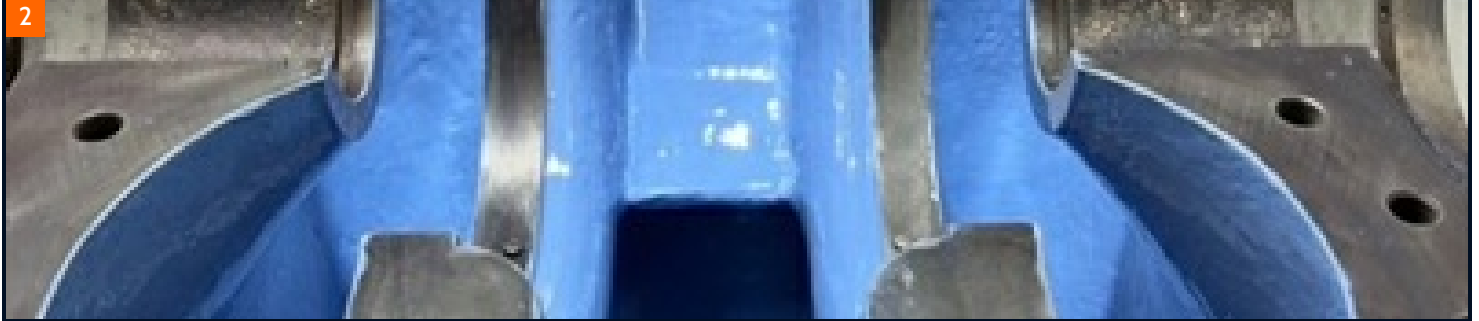
This cooling water pump had severe pitting and the customer wanted to replace it, however the lead time was over 6 months. I talked to the customer about letting us blast, pitfill and coat this one. They were in a bind because they only had a 5 day window to get this pump back in service or they would have to shut down the plant.

1. Pump before the application.
2. Pump after 1121 and 1341.

We had the pump delivered to our shop and blasted it to bare metal. Used 1121 to fill the pitting and then 2 coats of 1341
