# BELZONA COATINGS RESTORE SEVEN CHILLERS AT GLOBAL HQ OF OIL AND GAS COMPANY

ID: 10099

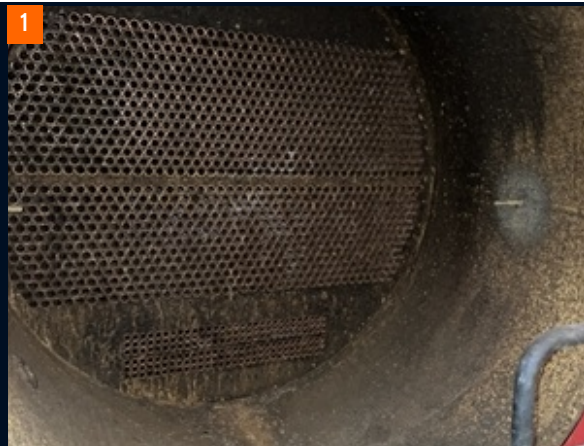
1. Condition of the asset before Belzona was applied.
2. After the abrasive blasting was completed, SSPC-SP10.
3. After Belzona 1121 was used to pit fill the tube sheet.
4. After the final coating of Belzona 1331 was applied.

1. The asset was opened, drained and dried using fans.
  2. A containment was built by screwing together a wood frame and taping sheets of poly around it, to make an air tight enclosure.
  3. Corks were used to plug the tubes.
  4. Abrasive blasting was completed to achieve a minimum 3mil profile, SSPC-SP10.
  5. Belzona 1121 was used to pit fill as needed.
  6. Belzona 1331 was applied in a two coat system over the entire application area.
- The application was performed on 7 chillers, including both ends of each chiller, the tube sheets, water box, and end covers. The work was done one chiller at a time. We used a dehumidifier and heater to help control conditions inside the containment and for the cure process.
