# BELZONA REPAIR AND PROTECTION OF STABILISER SHAFT

ID: 101

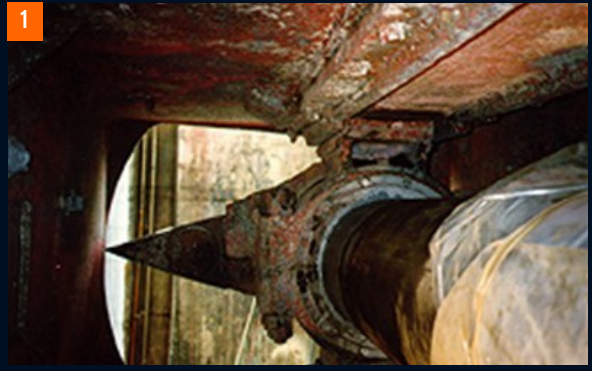
1. General view of the stabiliser shaft
2. After grit blasting, degree of erosion-corrosion damage clearly evident
3. Application of Belzona 1111 being completed

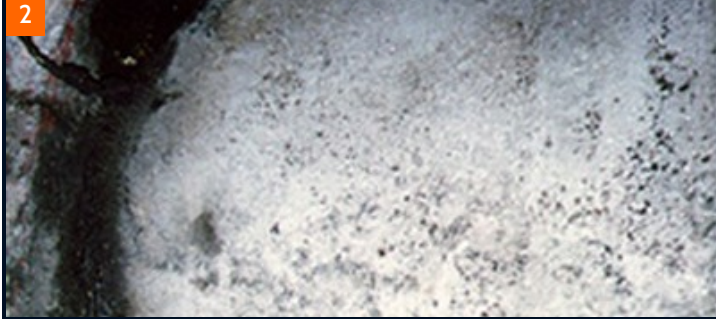
Severe pitting corrosion in-board of bearing.
