# BELZONA RESURFACES LAB TABLES

ID: 1010

At Georgia Tech, customer wanted to provide a durable surface without having to replace soapstone tables of 40 years of wear and tear have degraded tables.

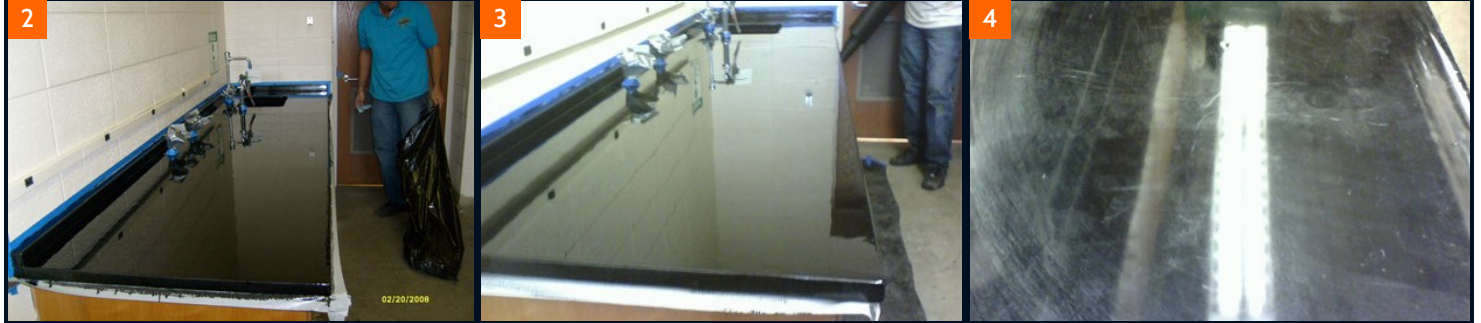
1. View of original table
2. Application of first coat
3. Completed application
4. After 5 years, another lab top table was being repaired. Lab was being rebuilt, but the tops were remained.

Sanding tables to provide a good profile. Then applied two coats of Belzona 5811.

The university was able to refurbish the tables and labs at a fraction of the cost to replace. The table tops were refurbished in two days as compared to two weeks for replacement.
