# REPAIR OF SHIP DECK USING BELZONA

ID: 10100

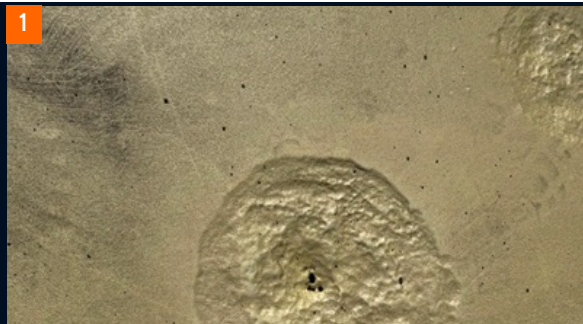
A routine inspection revealed that the steel deck had suffered from heavy corrosion, resulting in noticeable metal loss and the formation of multiple pinholes. This level of deterioration posed a threat to the deck's operational reliability, highlighting the need for an effective and long-lasting repair solution.

1. Evident pinhole damage on steel deck
2. Multiple damaged locations on the steel deck
3. After surface preparation to SSPC-SP11
4. Completed Belzona application

Surface preparation was completed using a rotary power tool to achieve an SSPC-SP 11 Power Tool Cleaning to Bare Metal standard. This produced a clean and consistent anchor profile suitable for rebuilding with Belzona. All surfaces were then cleaned using a residue-free solvent to remove contaminants and ensure proper adhesion. Belzona 1111 (Super Metal) was then mixed and applied to rebuild the corroded sections and reinstate the deck to its original geometry. The material was worked and feathered to blend smoothly with the surrounding steel, restoring surface integrity, encapsulating the previously visible corrosion patterns, and protecting the rebuilt areas against future corrosion.

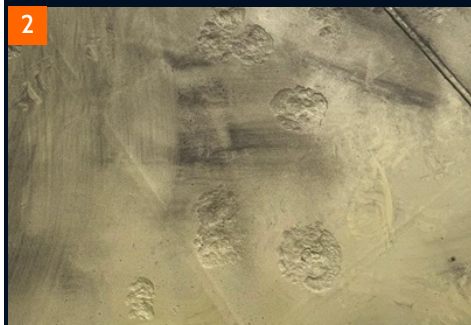
During inspection of the vessel's monkey island (upper deck), several areas of the steel deck were found to have recurring corrosion patterns showing through despite recent painting. The client needed a fast, controlled repair that avoided hot work and heavy equipment. Conventional grit blasting was not feasible due to the location and operational constraints, so a cold-work solution was required to restore the deck and its profile.
