# BELZONA 5871 SOLVES CUI PROBLEM AT REFINERY

ID: 10101

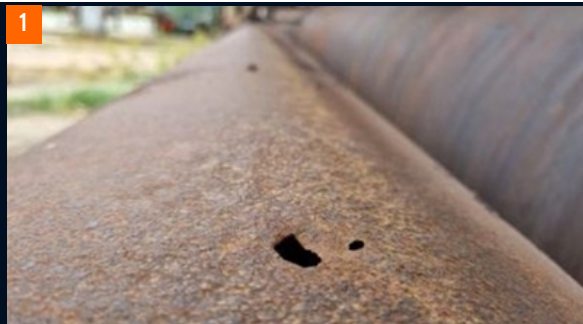
A refinery contacted us to solve a CUI (Corrosion Under Insulation) problem with their carbon steel pipeline. The pipeline had been in operation for 20 years, 24 hours a week and had a very high corrosion status which had caused loss of thickness, causing perforations and therefore benzene to leak out from the pipeline.

1. Damaged pipeline
2. Belzona 5871 being applied to new pipeline
3. Completed application
4. Completed application
