# BELZONA 1813 SAVES FIBERGLASS SPRAY HEADERS

ID: 10104

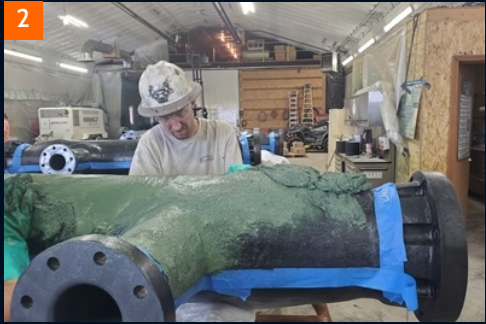
2

1. Application of Belzona 1813 to new headers in their shop.
2. Smoothing out the Belzona 1813 on headers.
3. Closeup of contractor finishing up on a header.
4. Finalized application and contractors wearing new Belzona t-shirts!

New fiberglass piping was manually prepped with grinders, cleaned and Belzona 1813 was applied by hand.
