# CONCRETE LEAK SEAL IN HOSPITAL PARKING GARAGE CAUSING GREASE LEAKAGE ONTO PHYSICIAN'S VEHICLE

ID: 10107

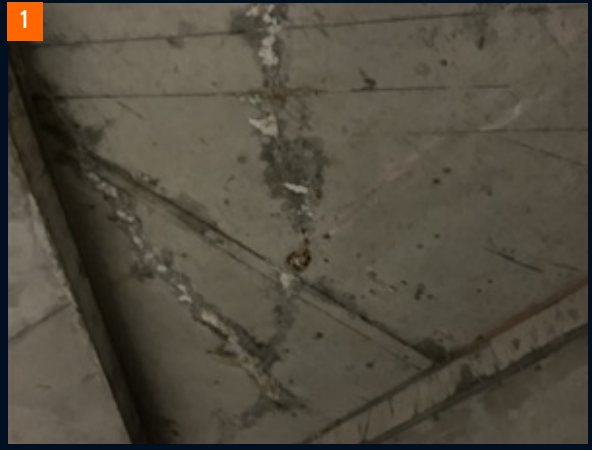
In the prominent medical center of Houston, TX, one Hospital facility has an underground parking garage below one of the building towers on their campus. The garage is used by everyone from patients to employees. One location in the garage, has a crack in the ceiling, that has grease dripping through it. It happened to fall right onto a Physicians vehicle in a reserved parking spot. This caused an issue between the Physician and Hospital, and needed immediate repair.

1. Long crack in the ceiling of the garage, before image.
2. Belzona 9611 and 1212 used to composite patch crack and stop the active leak.
3. Belzona 3121 and 9331 applied to patch the crack and perimeter seams.
4. Entire ceiling area sealed with Belzona 3121 and 9331
