# WEAR RESISTANCE COLD BOND PLATING

ID: 10110

## PROBLEM

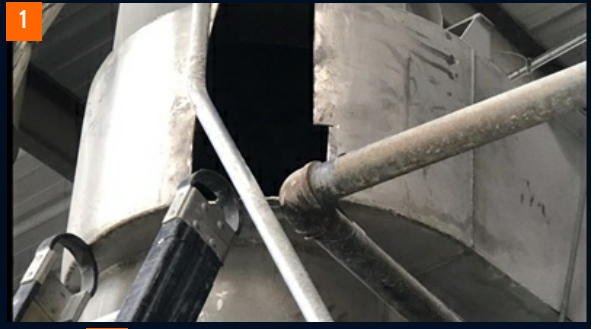
This small cyclone was faced with years of wear from the material this plant produces. This facility produces the granules that sandpaper and grinding wheels are made from.

1. The first picture is where the granules had eaten away the surface of the cyclone. We had to cut it out to make it a better sealing surface.
2. Then we applied Belzona 1111 for the adhesion of the plate along with Belzona 1812 to the center of the plates for wear resistance.
3. Next we applied the first plate using Belzona 1111.
4. Then we applied the final piece that was custom made for this application. (Note the handles) This piece was really heavy due to the material it was made from and the added weight of Belzona. But this allowed for removal and touch up for future use.

We used grinders to cut away the jagged edges and to create a smooth edge. Then we used the MBX Bristle Blaster to prepare the surface for adhesion. We applied Belzona 1111 and 1812 with Belzona supplied knife and applicator pad.
