# PROPELLER REPAIR & COATING

ID: 10111

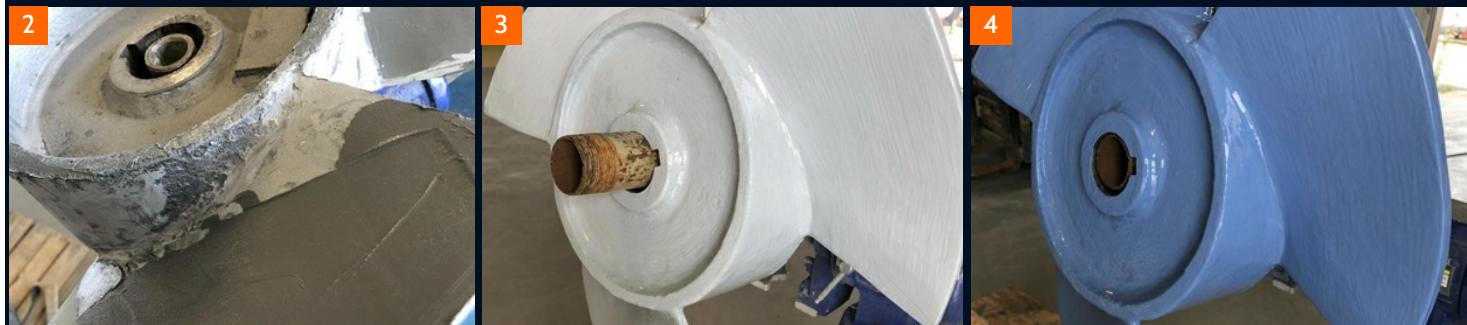
This propeller had seen years of pumping water out of a slough due to high water during rain or Beaver dams backing the water up. The propeller had seen water, tree limbs and rock that caused the damage.

1. This picture is of the damaged propeller.
2. Once we cleaned and grit blasted the propeller we started making the repairs using Belzona 1111.
3. This is after repairs were made and the application of the first coat of Belzona 1321.
4. In this picture you have the completion of the repairs and coating using Belzona Super Metal 1111 for the repairs and Belzona 1321 Ceramic Coating.

We cleaned the propeller using 100% MEK followed by grit blasting to a 3 mil profile. We used the provide tools from Belzona to apply the Belzona 1111 and a stiff brush to apply the Belzona 1321.
