# MAIN CONDENSER EXPANSION JOINT SAVED

ID: 10115

## PROBLEM

The expansion joint was 75 % gone and needed to be replaced.

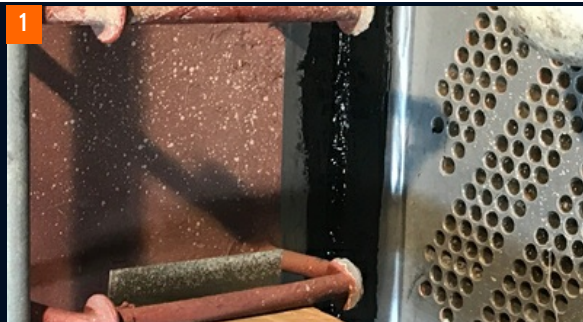
1. Closeup of Belzona 2111 elastomer expansion joint in main condenser
2. Belzona 2111 application reinforced with reinforcement mesh replacing expansion joint
3. Close-up of final expansion joint using Belzona 2111 elastomer
4. Belzona 2111 completed application

The joint area was blasted and cleaned, Belzona 2911 was applied on entire surface area, and the Belzona 2111 reinforced system application was carried out during outage.
