# BELZONA PROTECTS HYDROELECTRIC PENSTOCK

ID: 1012

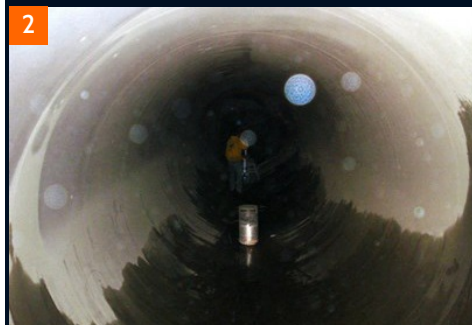
1. Penstock feeding into diffuser vanes in plant
2. Looking down the penstock
3. Belzona 5811 applied by spray
4. Application completed
