# BELZONA 1341 ENSURES RELIABLE HEAT EXCHANGER PERFORMANCE DURING A MAJOR TURNAROUND

ID: 10120

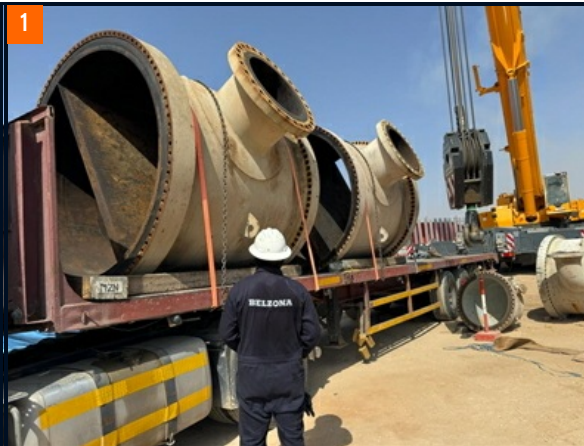
1. General Overview of the Cooling Water Channel Heads
2. A heat exchanger channel head in a petrochemical plant had suffered significant corrosion-erosion, resulting in wall-thickness loss.
3. After Grit Blasting Surface Preparation
4. Completed application of Belzona 1341 (Supermetalglide) on the heat exchanger channel head.

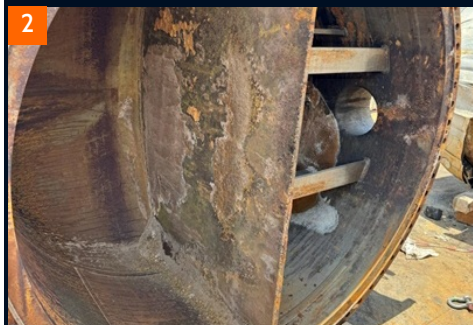
The customer was experiencing corrosion and erosion on the channel heads of cooling water heat exchangers. Over time, this resulted in metal loss, pitting, and surface deterioration, compromising the integrity of the equipment, increasing the risk of leakage, and reducing overall heat transfer efficiency.

- Surface preparation was performed by grit blasting to achieve the required surface profile, followed by thorough cleaning with Belzona 9111 (Cleaner Degreaser).
- Belzona 1111 (Super Metal) was then applied to rebuild the damaged areas.
- Belzona 1341 (Supermetalglide) was subsequently applied to provide a smooth, corrosion-resistant protective coating.
