# SECONDARY CHEMICAL CONTAINMENT

ID: 10121

## PROBLEM

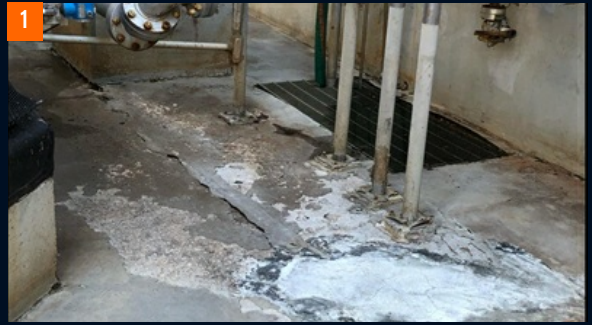
This secondary chemical containment had never been coated and has seen several spills over the last few years. This has caused severe damage to the concrete and sump pit area where water/chemicals had stood until it was pumped out.

1. Before picture of the containment area where you can see the damaged areas.
2. Close up of the sump pit area. Here you can see how bad the concrete had deteriorated between the sump pit and exterior wall of the containment.
3. In this picture, after we removed all loose and damaged concrete we thoroughly cleaned the area to be repaired with 100% MEK and began to prep the surface with grinders and needle guns. Once we achieved the correct surface prep we applied Belzona 4111
4. Once the repair was complete we applied 2 coat of Belzona 4311. In this application we perform a yearly inspection for the client.
