# BELZONA 1111 & 5815 REPAIRS AND PROTECTS FIBERGLASS TANK AT CHEMICAL PLANT

ID: 10130

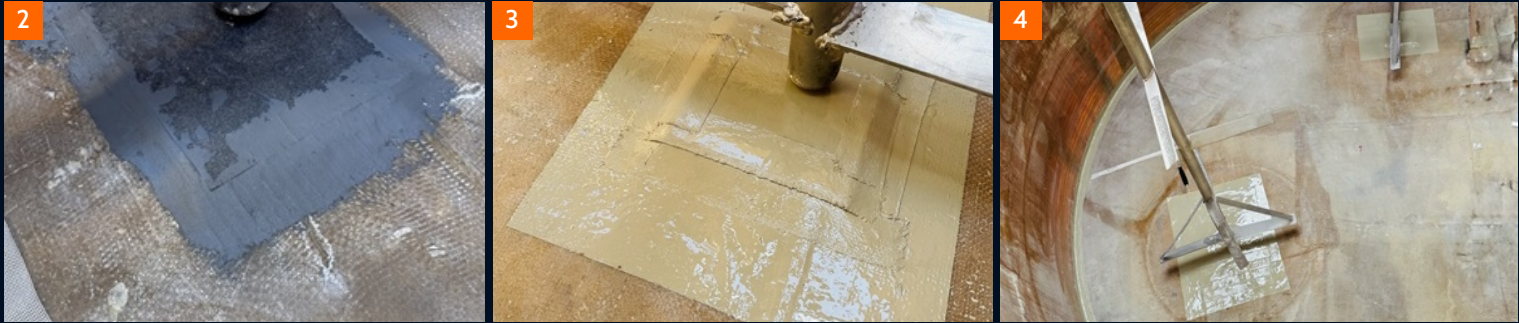
Our client's fiberglass tank had a few small hairline cracks where the chemical aluminum sulfate would seep out. They had an inspection report done and it was found they needed repairs.

1. Worn damaged fiberglass area
2. Belzona 1111 with Reinforcement Cloth shown over a cold plate bond on floor of fiberglass tank
3. Belzona 5815 and Composite Reinforcement Wrap Overlay on 1111 Repaired Areas
4. Aerial view of 5815 repairs in tank

First, the areas for repair were sandblasted for a roughened profile. We then sanded and grinded areas that were chipping or needed to be feathered in. Belzona 1111 was applied with reinforcement cloth to areas that were thin and in some areas we did a cold plate bond over any voids. We then overlaid those areas and tank seams with Belzona 5815 and composite reinforcement cloth.
