# SECONDARY CONTAINMENT REPAIR & COATING

ID: 10134

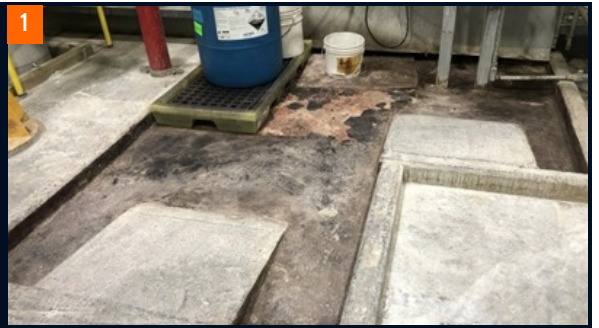
The client was facing deteriorating concrete due to chemical spillage when replacing the chemical storage container.

1. You can see the damaged concrete areas in this picture from the chemical spillage.
2. We had to make a few deeper concrete repairs using Belzona 4111 before moving forward.
3. Once the other areas had been repaired we skimmed most of the containment area to bring back to level using Belzona 4111
4. Here you can see the completed application using Belzona 4311 due to high concentration of chemical.

We first began by neutralizing the affected area. Then we began to remove loose and damaged concrete with needle guns and hand grinders. Once the damaged areas were prepped we began to apply Belzona 4911 Conditioner followed by Belzona 4111 to fill pockets of damaged areas followed by skimming the containment area to level the floor and for proper drain. Next we applied two coats of Belzona 4311 to the containment and curbing and providing a little extra protection by carrying the coating over the curbing and ramp.
