# BELZONA RESTORES A CONE SHAPED CYCLONE SEPARATOR

ID: 10137

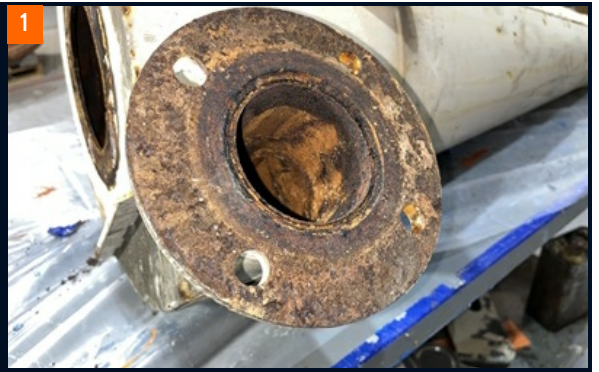
The customer had a cyclone separator that constantly vibrates to separate solids inside. The process over time eroded the metal and created through wall defects. The cost & time for a replacement was not feasible. Weld repair was not possible because the asset had thin metal and a unique geometry. The customer was looking for a cost effective solution that allowed a quick return to service.

1. Before image of a flange and externals
2. Pin holes found after blasting
3. External repair completed on the top nozzle piece
4. External repair completed on the main body of the separator

1. The asset was sent to our shop for work to be done over a weekend.
2. The asset was abrasive blasted to SSPC-SP10 standard and wiped clean with Belzona 9111 degreaser.
3. Belzona 1311 paste was applied to plate bond over any through wall defects, pit fill, and smooth welds as needed.
4. Belzona 1311 was applied by hand to rebuild the flange faces to create a flat surface. After dimensionally stable, the 1311 was sanded flush best effort.
5. Belzona 1381 was applied in a two coat system to the internals of the asset.
6. Belzona 1381 was applied with 9341 mesh to composite wrap the bottom 24" externally, and the top nozzle.
7. Visual inspection and touch ups completed. Product was allowed to cure, and returned to customer.
