# COOLING TOWER PIPE COATING

ID: 10139

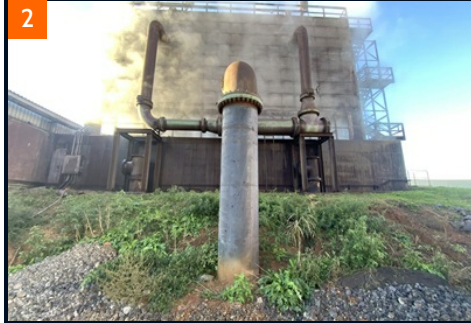
The client was facing deterioration on their exterior piping to the cooling tower from years of exposure to the elements without a coating.

1. Exterior cooling tower piping before any prep or Belzona coating.
2. Photo after pressure washing only.
3. After applying Belzona 5831
4. Close up of Belzona 5831
