# SAVED SPOOL PIECE WITH BELZONA

ID: 10146

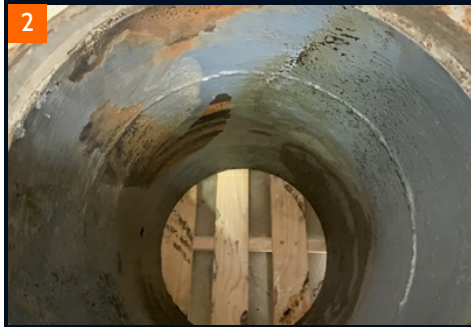
1. Before picture of the spool piece.
2. You can see the old coating had started to wear off.
3. After blasting to a 3 mil profile and first coat of Belzona 1321
4. Completed photo of spool piece with two coats of Belzona 1321

For this application we first blasted the surface to a 3 mil profile followed by cleaning with 100% MEK. Next we applied two coats of Belzona 1321 using a stiff bristle brush.
