# ROTOCLONE WET DUST COLLECTOR - EXTERNAL PLATE BOND REPAIR

ID: 10148

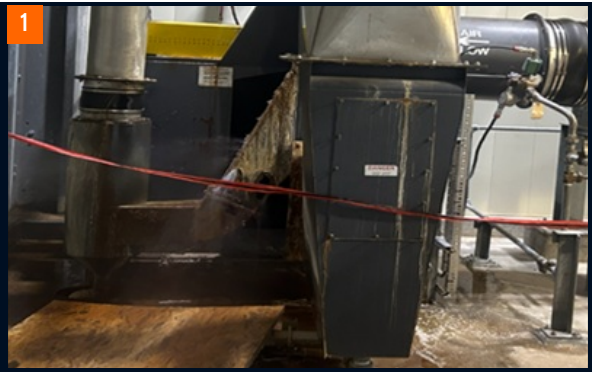
The customer had a critical piece of equipment, a RotoClone™ Wet Dust Collector, that experienced through wall corrosion at the exhaust vent. The dust collector uses centrifugal force and a water spray to efficiently capture dust, mist, and sticky particulates from industrial air, effectively cleaning the air for recirculation, protecting workers, and preventing explosions in harsh environments. Over time, one exhaust vent established a through wall defect after years of service. The moisture going through the exhaust vent was now coming out of the holes that were developed, creating a safety hazard and inefficient equipment.

1. Asset in service, with moisture coming out of the defects. Area has red tape to prevent access. Moisture spilling on the floor.
2. Surface prep complete with power tools.
3. Plate bond application.
4. Plate bond application.
