# BRASS IMPELLER REPAIR AND COATING

ID: 10149

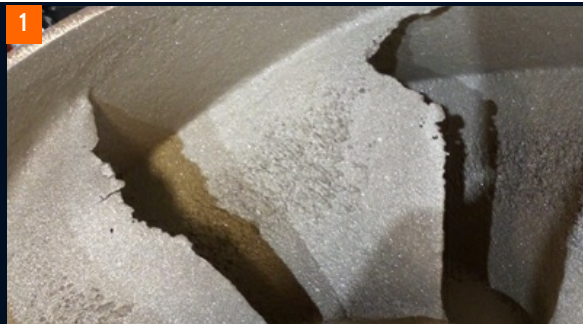
The client took a pump out of service for inspection and found several problem areas. The impeller being one of them. The leading edges were worn almost half way off.

1. Notice leading edge of impeller blades
2. Giving this impeller back its leading edges
3. After Belzona 1111 metal repair
4. After two coats of Belzona 1321
