# MOP SINK WATERPROOFING AND LEAK PREVENTION USING BELZONA 3121

ID: 10150

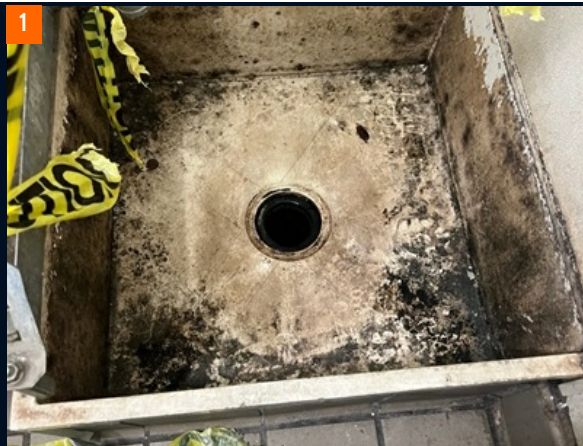
Water was leaking through the gap between the mop sink and the surrounding wall and floor areas. This allowed water to bypass the sink and infiltrate the building structure, causing water damage and leaks on the floors below. The existing sealant had failed, and repeated exposure to water and cleaning chemicals increased the risk of ongoing leakage, deterioration of surrounding substrates, and maintenance issues throughout the facility.

1. Mop sink showing water infiltration points around the drain and wall interfaces prior to repair. Gaps between the sink, walls, and drain allowed water to escape the basin and leak to lower floors.
2. Close-up of the drain penetration sealed using Belzona 3121 (MR7) to prevent water migration around the pipe connection.
3. Completed repair using Belzona 3121 (MR7), creating a continuous waterproof seal directing water into the drain and preventing further leakage.

Belzona 3121 (MR7) was applied directly to the gap between the mop sink and the wall to create a continuous waterproof seal. Belzona 9331 reinforcing sheet was embedded into the first layer where required, followed by a second coat of Belzona 3121 to fully encapsulate the joint. The drain outlet was also reinforced to prevent future leakage. The system was allowed to cure, forming a seamless, flexible, and watertight barrier.
