# REPAIR OF A DEFORMED AND LEAKING 36 INCH CRUDE OIL PIPELINE USING

ID: 10151

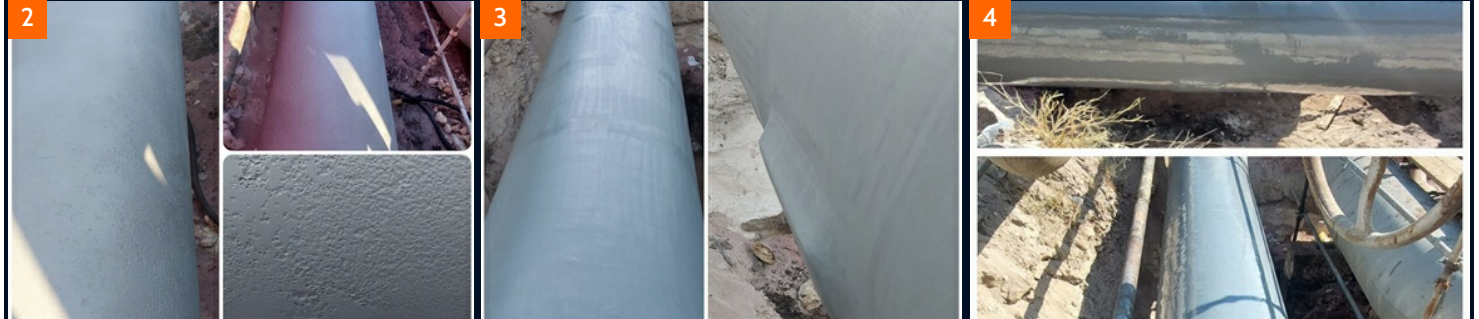
Severe external corrosion, combined with continuous loading from the support structure, caused structural deformation and the formation of a pinhole leak in a 36 inch crude oil pipeline operating at ambient temperature and 4 bar pressure. Approximately 5 meters of the pipeline experienced significant wall-thickness loss, posing a high risk to operational safety and continuity.

1. Pipeline damage caused by severe external corrosion
2. Pipeline condition after surface preparation by grit blasting
3. Pipeline condition following plate bonding using Belzona 1221 and wrapping with Belzona 1161 (Super UW-Metal) and Belzona 9341
4. Pipeline condition following application of Belzona 5831 (ST-Barrier) for external corrosion protection

The pipeline was first shut down, and all oil residues were thoroughly cleaned from the external surface. The pinhole area was sealed using Belzona 9611 (ES-Metal) and Belzona 1221 (Super E-Metal) to prevent oil sludge flow under high ambient temperatures (35°C).

After inspection and confirmation that the Lower Explosive Limit (LEL) level was zero, abrasive blasting was carried out to achieve a minimum surface profile of 75 microns and Sa 2.5 cleanliness. A steel plate was then blasted and bonded to the 36" pipeline using Belzona 1221 to correct the deformation and restore structural integrity.

To provide long-term reinforcement, a two-wrap composite system using Belzona 1161 (Super UW-Metal) and Belzona 9341 (Lagseal Reinforcing Sheet) was applied along the affected section of the pipeline. Finally, Belzona 5831 (ST-Barrier) was applied as a topcoat to protect against future external corrosion.
