# CERAMIC TILE COMBINED WITH SUPER WRAP II

ID: 10152

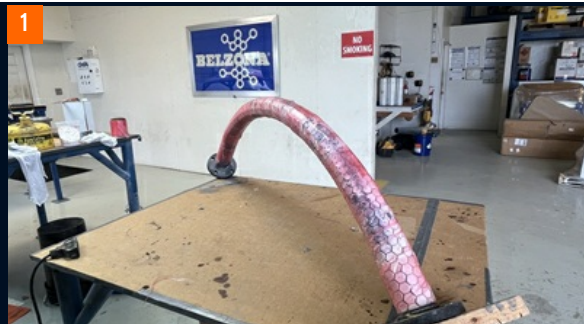
1. After applying ceramic tile and pre-fitting for Super Wrap II.
2. Applying 5821 with Cabosil to fill in as a grout and add some wear resistance.
3. Applied Super Wrap II using Belzona 1984
4. Completed wrap after applying the consolidation tape.

We began by blasting the pipe to a 3 mil profile and cleaned the surface using 100% MEK. Next we pre-fit our tile and cut to fit. Then we used Belzona 5821 with Cabosil to apply the tile, working it into the surface of the pipe and on to the back of the tile. After applying the tile we then used more Belzona 5821 with Cabosil to fill in the grout lines and coat the surface of the tile. After proper cure time we then pre-fit the Super Wrap II and applied two wraps using Belzona 1984. To complete the application we applied the consolidation tape and let cure the proper time. We have set up an inspection period with the client for every six months.
