# PARTY SUPPLIER IN NEED OF BELZONA

ID: 10155

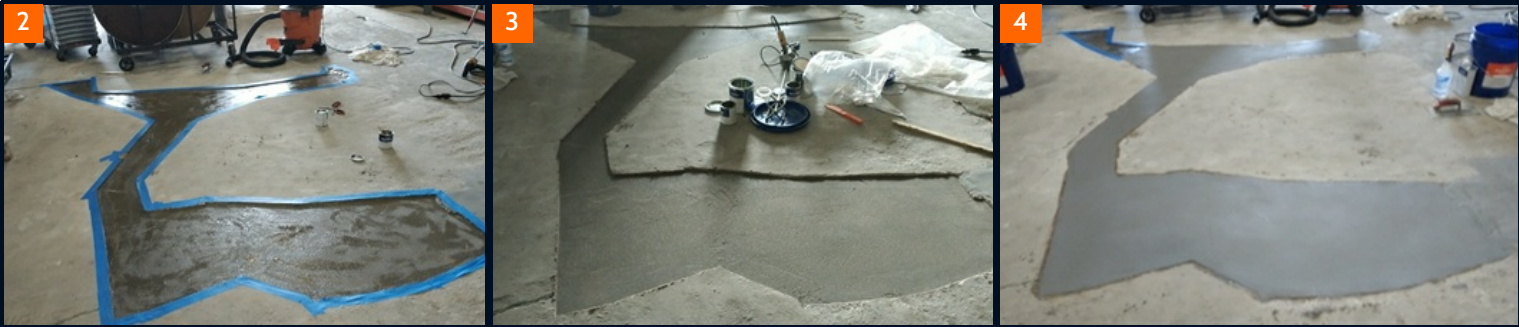
The surface of the concrete floor had become damaged due to heavy forklifts traffic and impact from heavy pallets being loaded and unloaded. The uneven surface was making it increasingly difficult for the the safe operation of their busy schedule.

1. Damaged sections of the floor
2. After surface preparation, the area was conditioned with Belzona 4911
3. The area was filled with Belzona 4124 except for the top 1/4 inch
4. Top 1/4 inch was filled with Belzona 4131

The application was completed in accordance with Belzona Know-How System Leaflet FPA-1. The concrete ramp was grinded down until safe and sound on concrete was found. The Belzona floor repair system was applied to the damaged area without interruptions.
