# MAJOR AIRPORT IN SOUTH FLORIDA NEEDS BELZONA FOR A SMOOTH ACCESS

ID: 10156

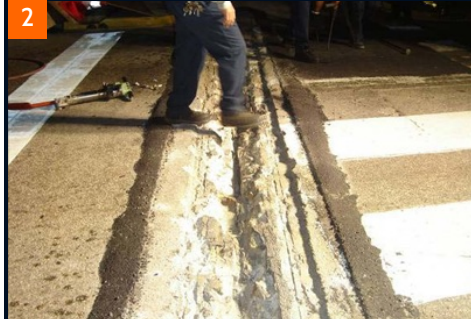
The failing expansion joints of the upper deck main access road to an international airport created serious safety concerns. The combination of the crumbling concrete joint nosings and the leaks to the lower decks required a high quality and long lasting solution.

1. Existing expansion joints
2. Surface preparation completed
3. Expansion joint nosings being rebuilt with Belzona 4111
4. Application completed

Application was carried out in accordance with Belzona Know-How System Leaflet FPA-5. Joint nosings were rebuilt with Belzona® 4111 prior to applying Belzona 2221 as new joint sealant.
