# BELZONA SOLUTION FOR WORN PUMP IMPELLER

ID: 10162

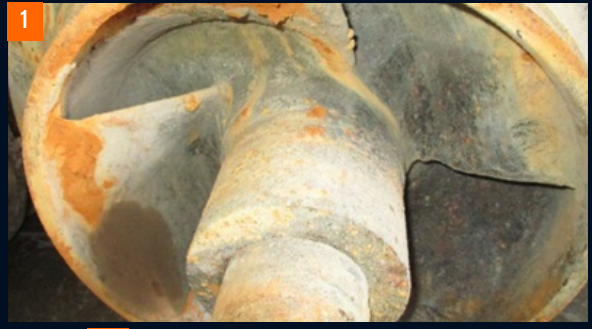
Damage surface on pump impeller caused by erosion and corrosion

1. Pump impeller showing damage caused by erosion and corrosion
2. Carbon steel surface prepared by grit blasting with steel grit to give a minimum depth of 75 microns and surface cleanliness by Swedish standard Sa 2.5
3. The first coat of Belzona 1331
4. After the second coat of Belzona 1331 was fully cured, it was inspected for holidays/pinholes with a PCWI low voltage tester and successfully passed.
