# FLUE GAS COMPRESSOR INDEX COVER REPAIR AND COATING WITH BELZONA

ID: 10168

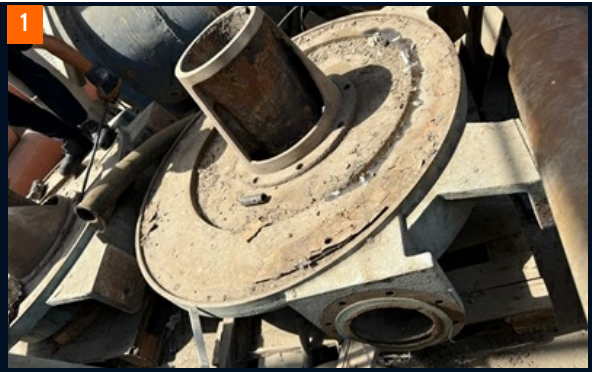
The pump cover had suffered severe erosion damage due to prolonged service conditions. As a result, the client classified the pump as scrap and placed it in the yard, assuming it was beyond economical repair.

The erosion had reduced material thickness, adversely affected hydraulic profiles, and raised concerns regarding reliability and continued operation. The pump cover was repaired and coated at approximately 20% of the cost of a new pump.

1. Eroded pump cover
2. Surface preparation carried out by grit blasting
3. Surface rebuilt using Belzona 1511 (Super HT-Metal)
4. Pump cover coated with Belzona 1391T
