# GLASS FUSED STEEL TANK SHELL REPAIR WITH COLD BONDING TECHNIQUE

ID: 10169

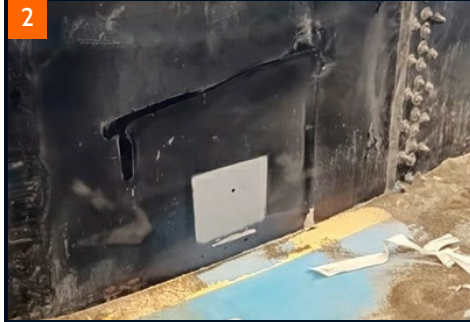
Leakage was observed due to the loss of effective corrosion protection at the bottom section of the tank shell, leading to accelerated corrosion, wall thinning, and eventual perforation under normal operating conditions.

1. Through-wall leakage at the bottom section of the tank shell
2. Surface preparation carried out by grit blasting
3. Plate bonding application using Belzona 1111 (Super Metal)
4. Drinking water tank condition after leakage repair

The repair was carried out while the tank was shut down. The metal plate was installed using Belzona 1111 (Super Metal) after the surface was grit blasted to achieve the minimum required surface profile and cleanliness.
