# DAMAGED PUMP PARTS REPAIR BY BELZONA SOLUTION

ID: 10171

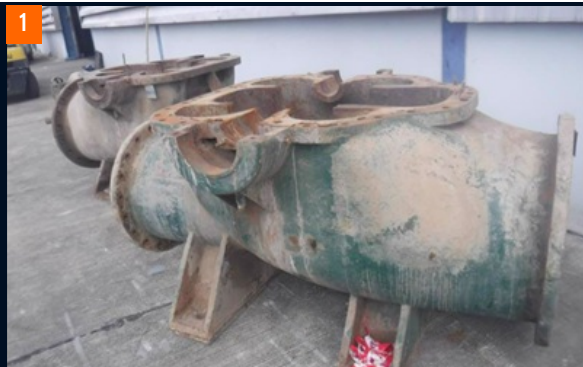
Pump components, including pump casing and pump impellers, were reported to have suffered from both corrosion and erosion damage. These issues affected the pump's operational efficiency and reliability. To avoid a high cost of pump replacement and operation downtime, the client contacted Belzona for a solution.

1. Damaged pump casing was delivered to the workshop for repair
2. Damaged pump impeller before the repair
3. Pump casing repaired with Belzona 1121 (Super XL-Metal) and coated with Belzona 1341 (Supermetalgilde)
4. Pinhole check on pump impeller after Belzona 1331 coating

1. Carbon steel surface was prepared by blasting with steel grit to give a minimum depth of 75 microns, and Surface cleanliness by Swedish standard Sa 2.5
2. Use a vacuum cleaner machine to remove all loose contaminants and clean the surface with Methyl Ethyl Ketone.
3. For the casing, apply Belzona 1341 (Supermetalgilde) at a dry film thickness of 250 microns as the first coat. For the impeller, apply the first layer of Belzona 1331 at a dry film thickness of 375 microns.
4. For pitting damage area on the casing and impeller, Belzona 1121 (Super XL metal) was used to rebuild the profile.
5. Apply the second layer of Belzona 1341 (Supermetalgilde) at a dry film thickness of 250 microns. For impeller, apply the second of Belzona 1331 at a dry film thickness of 375 microns.
6. Allow the product to cure.
7. Use the PHYNIX DFT Tester to confirm the dry film thickness.

The severely pitted areas were filled with Belzona 1121 (Super XL-Metal), a two-component paste grade system with extended working life for repairing and rebuilding machinery and equipment.
