# REPAIR AND COATING SPLIT CASE PUMP AND IMPELLER BY BELZONA

ID: 10176

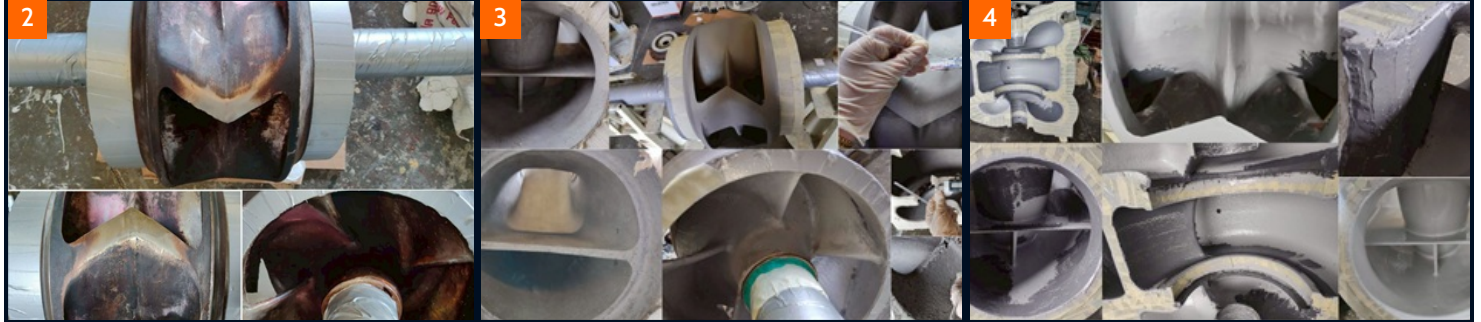
Split case pump and impeller were reported with severe erosion-corrosion damage.

1. Corroded surface area on pump casing
2. Corroded surface on impeller
3. Surface was sandblasted and cleaned with Belzona 9111 (Cleaner Degreaser) to give minimum profiles at 75 microns and surface cleanliness by standard Sa 2.5.
4. Application of Belzona materials on pump parts to rebuild pitted area and overcoat to protect against erosion-corrosion

1. Carbon steel surface was prepared by sand blasting to give minimum profiles at 75 microns and surface cleanliness prepared to ISO 8501-1 Sa 2.5 standard.
2. Clean and brush away and loose contaminant and then, clean the surface with Belzona 9111 (Cleaner Degreaser)
3. Check salt containment on the surface by the salt contamination meter SCM 400. The salt content should be less than 4 ug/cm<sup>2</sup>. If more than 4 ug/cm<sup>2</sup> was detected, the surface was then rewashed or re-blasted accordingly.
4. Once the desired profile was achieved, apply the first layer of Belzona 1331 at a dry film thickness of 250 microns.
5. The corroded area was filled with Belzona 1311 (Ceramic R Metal).
6. Apply the second coat of Belzona 1331 at dry film thickness 250 microns.
7. Check dry film thickness with PHYNIX DFT Tester.
8. Use the PCWI Low Voltage Tester to check the pinhole.

The proposed system incorporates Belzona 1311 (Ceramic R-Metal), which was used to rebuild areas damaged by erosion and corrosion. For long-term protection, Belzona 1331 is applied as the coating. This material is specifically designed to protect the immersed surfaces of machinery and equipment, making it highly suitable for pump components that handle fluid transfer.
