# PUMP COMPONENTS REPAIRED AND PROTECTED WITH BELZONA SYSTEMS

ID: 10177

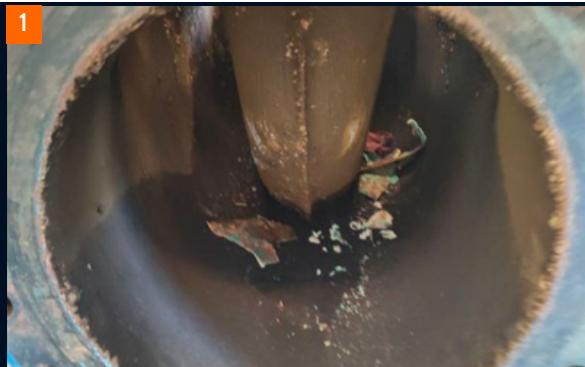
Severe corrosion had been identified on the pump casing and impeller, highlighting the need for a timely repair solution and corrective action to prevent further deterioration and avoid a costly full pump replacement. Having previously used Belzona on other pump units, the customer contacted Belzona to provide a solution to restore the pump's condition and extend its service life.

1. Corrosion and erosion damage on the lower pump casing.
2. Damage to the impeller caused by erosion and corrosion.
3. Surface preparation was carried out by sandblasting before the application of Belzona products.
4. The repair was completed and followed by a pinhole inspection before returning the pump parts to service.

1. The carbon steel surfaces of the pump casing and impeller were prepared by sand blasting to achieve a minimum surface profile of 75 microns and a surface cleanliness of Sa 2.5.

4. Once the required surface profile had been achieved, the first coat of Belzona 1331 was applied at a dry film thickness (DFT) of 250 microns.
5. Belzona 1311 (Ceramic R-Metal) was used to rebuild areas where severe metal loss had occurred.

6. A second coat of Belzona 1331 was then applied at a DFT of 250 microns.
7. After curing, the coating thickness was verified using a Phynix DFT tester.
