# BELZONA REPAIR SOLUTION FOR SPLIT CASE PUMP AND PUMP IMPELLER

ID: 10179

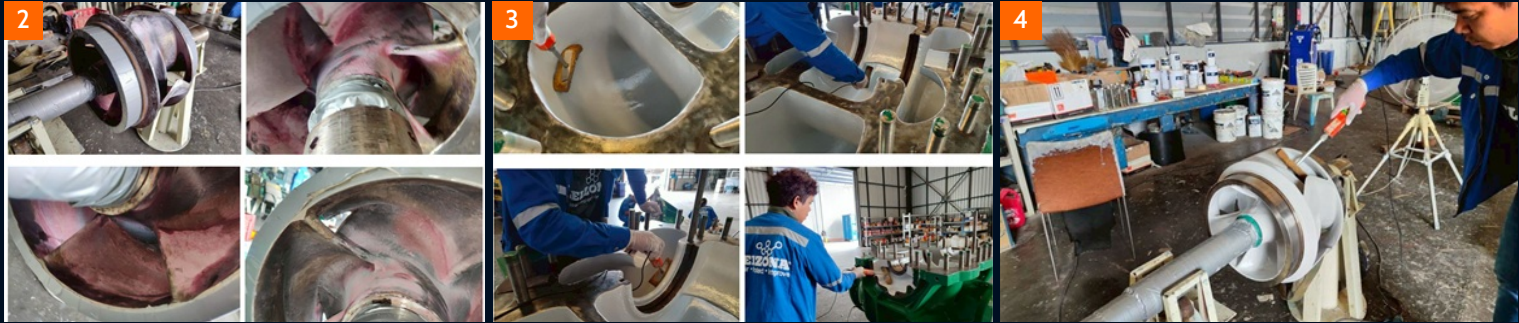
The pump components were damaged due to prolonged exposure to erosion and corrosion during service. This resulted in surface degradation, metal loss, and an uneven internal profile, which negatively affected efficiency and overall pump performance.

- 1. Corroded surface on lower casing
- 2. Pump impeller damaged by erosion&corrosion
- 3. Pinhole inspection on pump casing after the application was completed
- 4. Pinhole inspection on pump impeller after the repair was completed

- 1. Carbon steel surface on pump casings and impellers was prepared by sand blasting and cleaned with Belzona 9111 (Cleaner/Degreaser).
- 2. A minimum profile at 75 microns and surface cleanliness by standard Sa 2.5 was expected. TESTEX Tape and surface profile gauge were used to measure the profile.
- 3. Salt containment on the surface was measured to confirm that the salt content was below 4 µg/cm².
- 4. Once the surface was ready, Belzona 1331 was applied as the first coat and to fill the holes.
- 5. For any severely metal loss areas, Belzona 1311 (Ceramic R-Metal) was used to fill.
- 6. Apply the second coat of Belzona 1331, a two-component fluid grade system for protecting immersed surfaces of machinery and equipment suffering from erosion-corrosion.
- 7. Allow the product to cure before transporting the pump components back to the customer's premises.
